AN EVALUATION OF EXPERIMENTAL
REHABILITATION WORK,
REDWOOD NATIONAL PARK

TECHNICAL REPORT
JULY 1987

Redwood National Park Watershed Rehabilitation
Technical Report Number 19

National Park Service
Redwood National Park
Arcata, California
July 1987

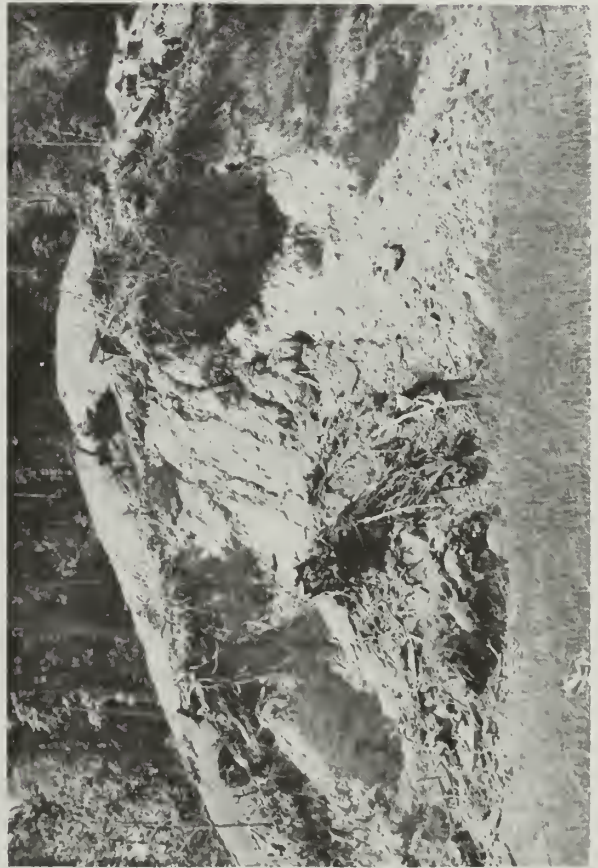
Fig. 22 (left). Unstable, slumping cutbank on the M-7-5-1 road.

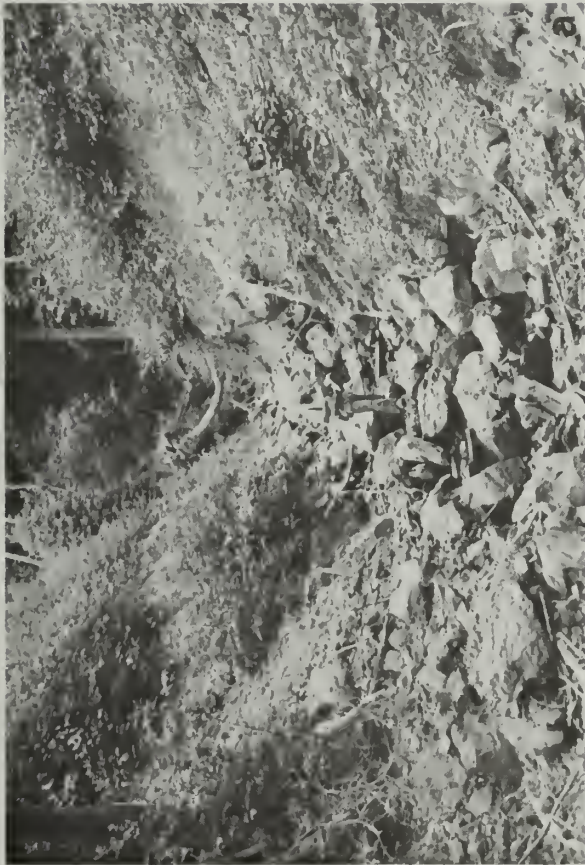
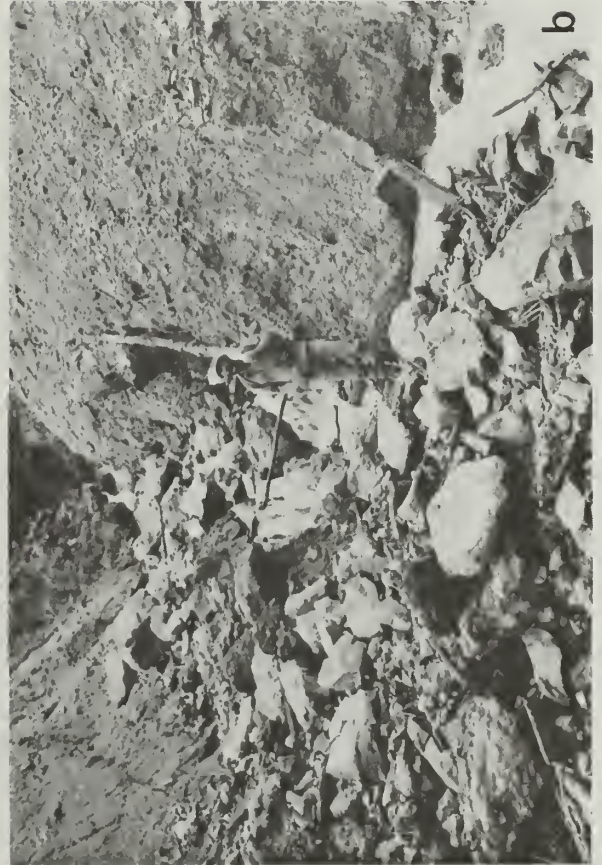
Fig. 31. Erosion of rock armored stream crossing R6. Sediment loss was caused by the presence of oversized rocks which diverted flow into and caused undercutting of the adjacent channel banks. Crossing R6 A) before heavy stream flows (October 1979) and B) after several winters (July 1982).

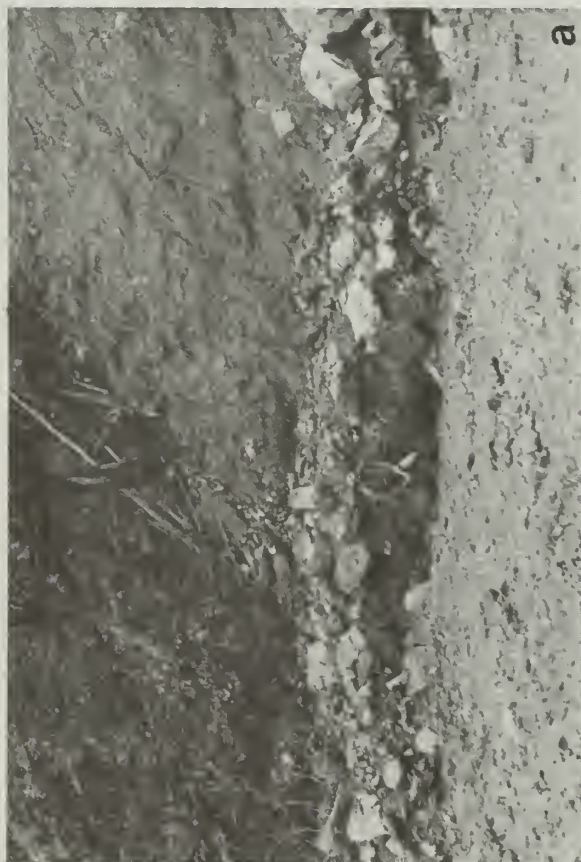
Fig. 32 (left). Excavated stream crossing R6. The two photos show views from A) top left edge of crossing, showing downcutting and terrace development along the right channel bank (rock armor is stranded above the new thalweg) and B) top right bank, showing consequent undercutting of the adjacent channel base. Photos taken October 1979.

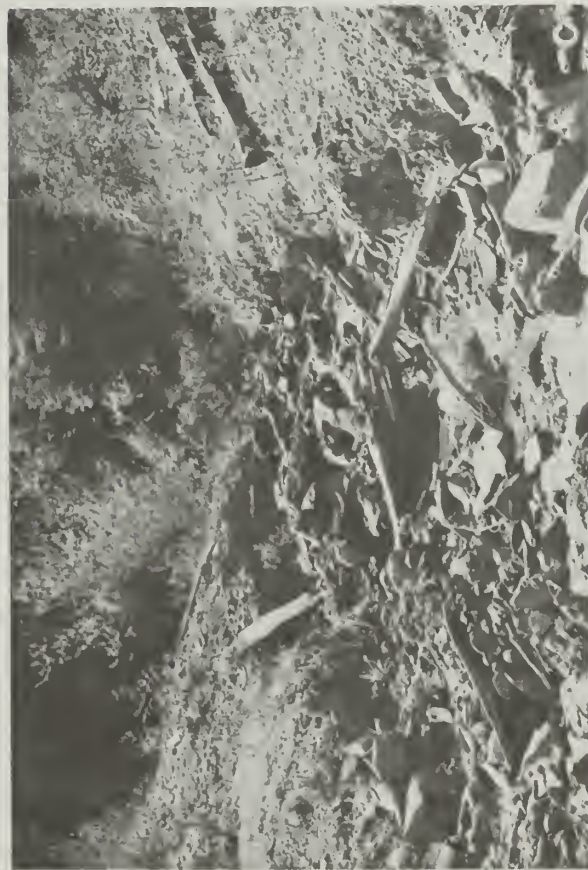
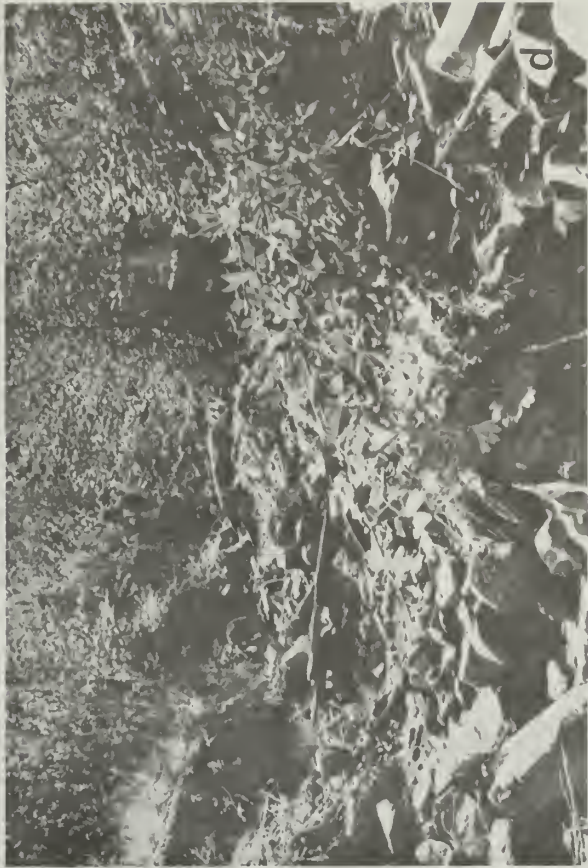
Fig. 79. Changes at an excavated stream crossing following rehabilitation. A) view upstream during the first winter flows; B) same view after first winter; note minor channel downcutting, considerable widening and the removal of under-sized rocks used in the channel armor; C) after the second year, the channel has downcut an additional foot and widened several more feet in response to sustained high flows during the winter (note the organic debris being exhumed); D) in 1983, 4 years after treatment, large boulders are now being exhumed as the stream finds its original, stable bed. Note also that widening continues to occur and young trees topple into the streambed.
